# Manhole Inspection Summary

Manhole # S31II\_018MH

Insp Date: **8/21/08 10:03 AM**

**Location** Address: **81 MOSHER ST**

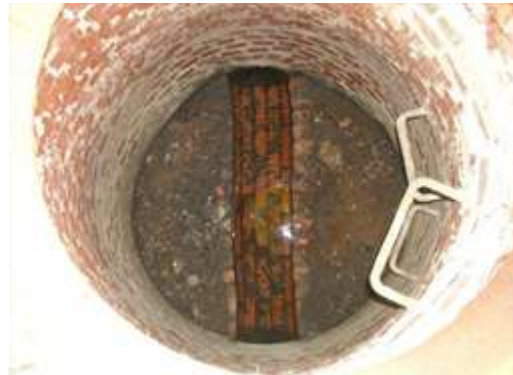
Top View

Frame leaks. Corbel and Barrel infiltration. Evidence of surcharge - Bench debris.

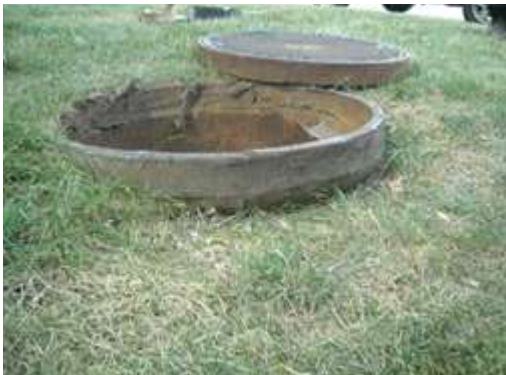
Defect

Above grade.

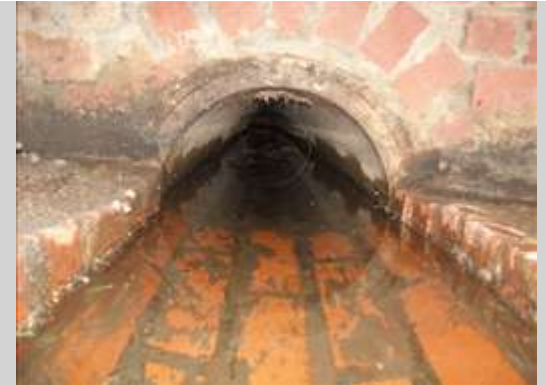
### 12 in. Circular Gravity Sewer Pipe Out @ 12 O'Clock

Pipe Material: **Clay** ☐ Pipe Lined

Invert Depth: **7.50** (ft.) Flow Characteristics: **Slow**

Infiltration: **Evidence**

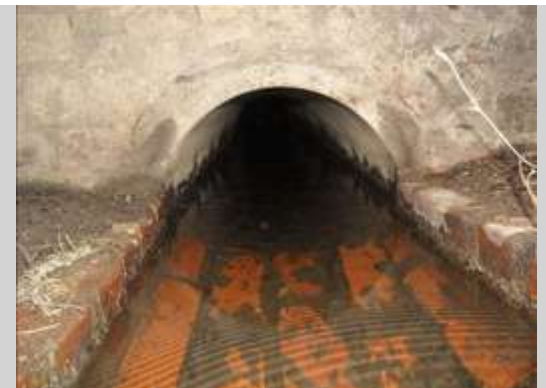
### 12 in. Circular Gravity Sewer Pipe In @ 6 O'Clock

Pipe Material: **Clay** ☐ Pipe Lined

Invert Depth: **7.42** (ft.) Flow Characteristics: **Slow**

Infiltration: **Evidence**
